Uniform Mitigation Verification Inspection Form

THE PERSON NAMED IN CORP.	j er mie reim wite wilj we cultici	provided with the moderation points
Inspection Date: 3/25/2014		
Owner Information		
Owner Name: Stonewater Condomin	Contact Person:	
Address: 1140-1148 Waterfall Lane		Home Phone: (863) 670-2299
City: Lakeland	Zip: 33803	Work Phone:
County: Polk		Cell Phone:
Insurance Company:		Policy #:
Year of Home: 1987	# of Stories: 2	Email: stonewatermanager@gmail.com

Elevation Photos

Roof Mitigation Upgrade Report

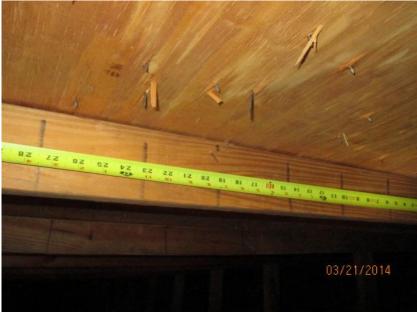
6d Nails Spaced 6" Along the Edge

Roof Deck Attachment. Our report reveals that the roof deck is nailed with a combination of fasteners and/or a fastening pattern that can be upgraded. When the time comes to update the roof, ensure that the roofing professional refastens the existing roof deck (or installs the new one) with at least 8d ring-shank nails, spaced a minimum of every 6 inches, on every single truss or rafter throughout your attic.

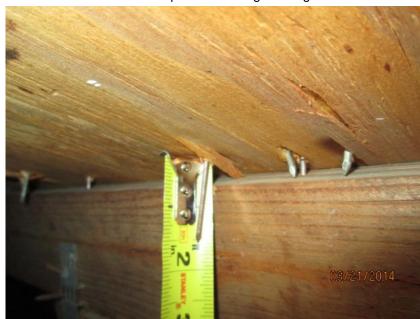
6d Nails

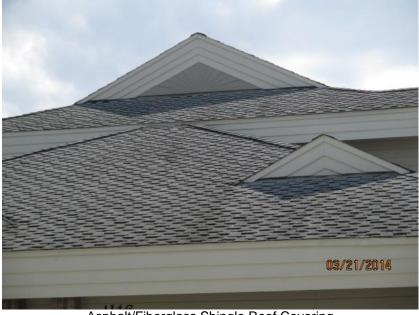
Asphalt/Fiberglass Shingle Roof Covering

Roof Covering Replacement. Our report shows that at least a portion of your roof was permitted prior to the adoption of the latest building codes. As a result, the next time your roof is replaced, it will receive credit for having a roof covering and installation that meets the very latest Florida Building Code requirements.

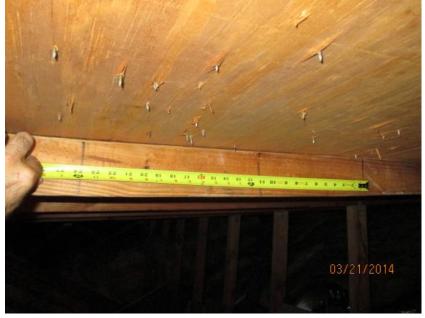
6d Nails Spaced 12" in the Field

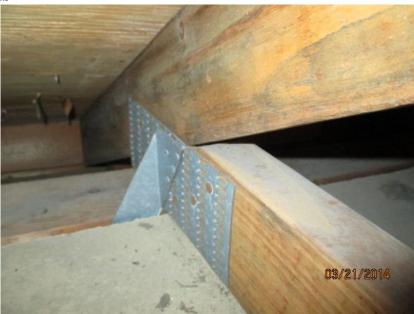
Clip with 3 nails on the front side and 0 nails on the opposing side

Roof-to-Wall Attachment Our report indicates that the existing roof-to-wall attachment(s) do not meet the requirements on the Uniform Mitigation Verification Inspection form for Single Wrap Straps. This definition requires at least two nails on the front side and at least one on the other of every strap in the attic, on every truss or rafter. As it is often difficult to access every truss or rafter, the ideal time to upgrade this feature is when the roof deck is being replaced. In some circumstances, this work can be done on its own; consult a professional for details.

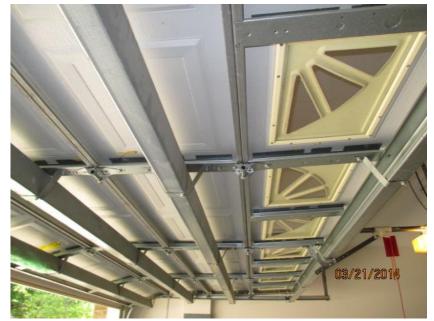
Unprotected Glazed Garage Door

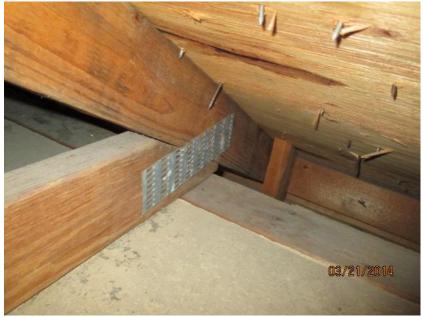
Clip with 3 nails on the front side and 0 nails on the opposing side

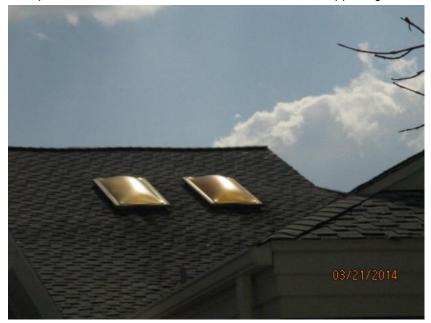
Unprotected Skylights

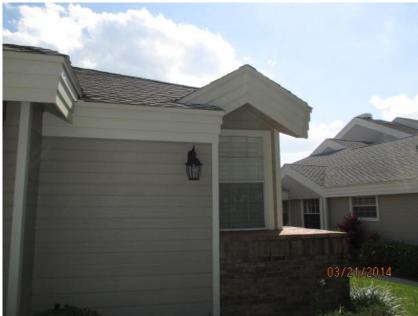
Unprotected Window

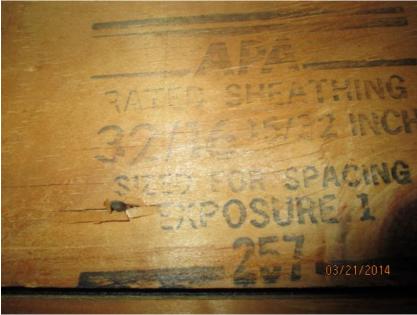
15/32" Deck Thickness Confirmed

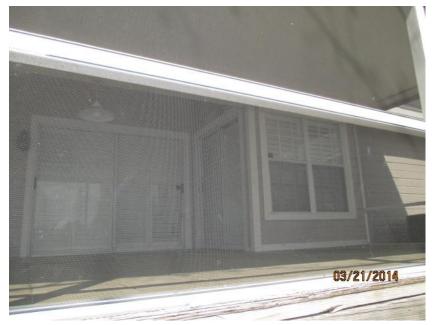
Unprotected Glazed Entry Door

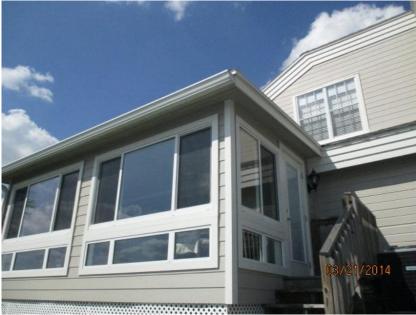
Unprotected Glazed Entry Door/ Windows

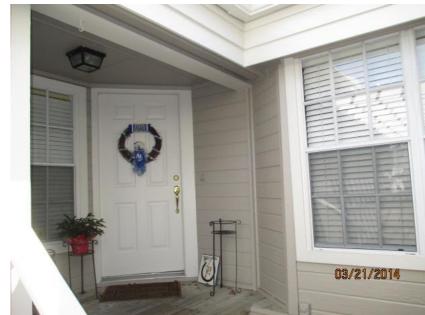
Unprotected Solid Entry Door

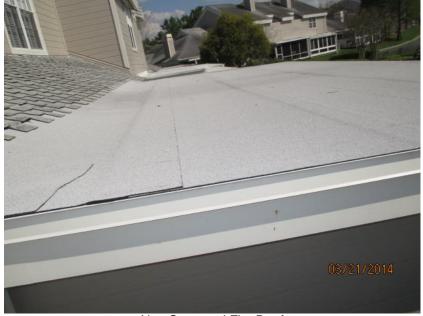
Non Structural Flat Roof

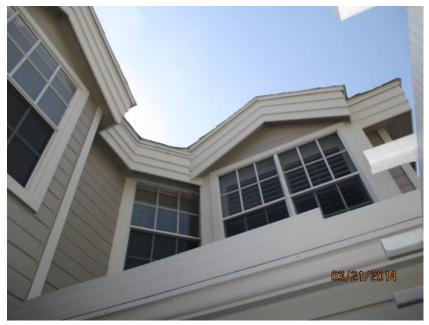
Unprotected Windows

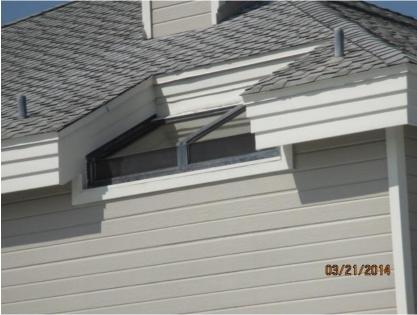
Unprotected Window
